RAILWAY INVESTIGATION REPORT
R05H0011

RUNAWAY AND MAIN-TRACK TRAIN COLLISION

OTTAWA CENTRAL RAILWAY
FREIGHT TRAIN NO. 441
MILE 34.69, ALEXANDRIA SUBDIVISION
MAXVILLE, ONTARIO
02 MAY 2005

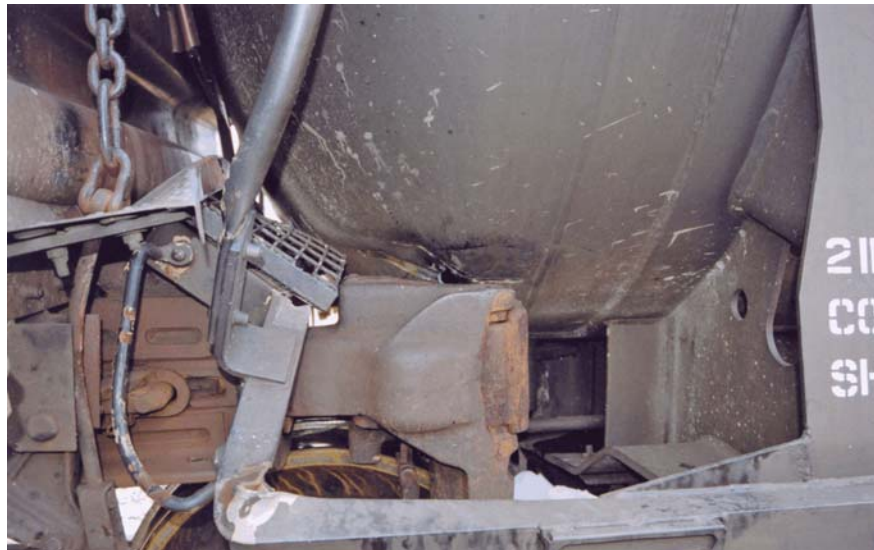
The two cars that collided, box car CN 557596 and tank car ADMX 29571, sustained impact damage. The B-end truck of the box car was displaced and pushed about 20 feet inward. The tank car head was dented and sustained a six-inch-long by two-inch-wide puncture (see Photo 1) caused by the box car's coupler.

Photo 1. Coupler of box car CN 557596 and punctured tank car ADMX 29571

Even though tank car ADMX 29571 was struck at low speed, the tank head did not withstand the impact of the box car's coupler and was punctured. This type of car has been involved in accidents previously investigated by the TSB, and its weaknesses have been acknowledged by the regulator and industry. The *Transportation of Dangerous Goods Regulations* have been modified to restrict the products these cars can carry, and design improvements that provide better valve roll-over protection have been implemented on newly constructed cars.

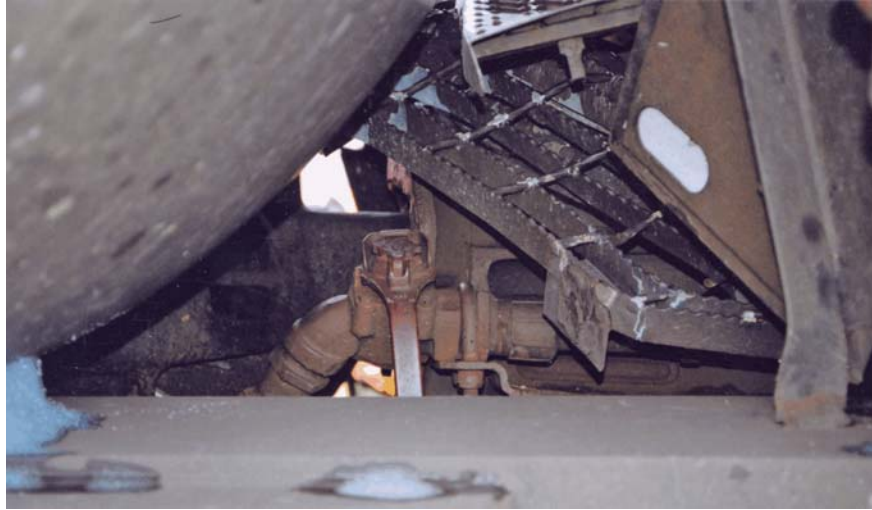
No pre-derailment damage of the equipment was observed and there was no track damage. It was noted that the angle cock on the B-end of the box car was fully closed (see Photo 2).

Photo 2. Closed angle cock of box car CN 557596

The train crew left a standing cut of 74 cars on a 0.5 per cent descending grade with the air bottled. These actions were not in compliance with either CN's System Special Instructions regarding CROR Rule 112 or the company GOIs. While bottling the air does not always lead to adverse consequences, the practice increases the risk of premature brake release that results in uncontrolled runaway cars.

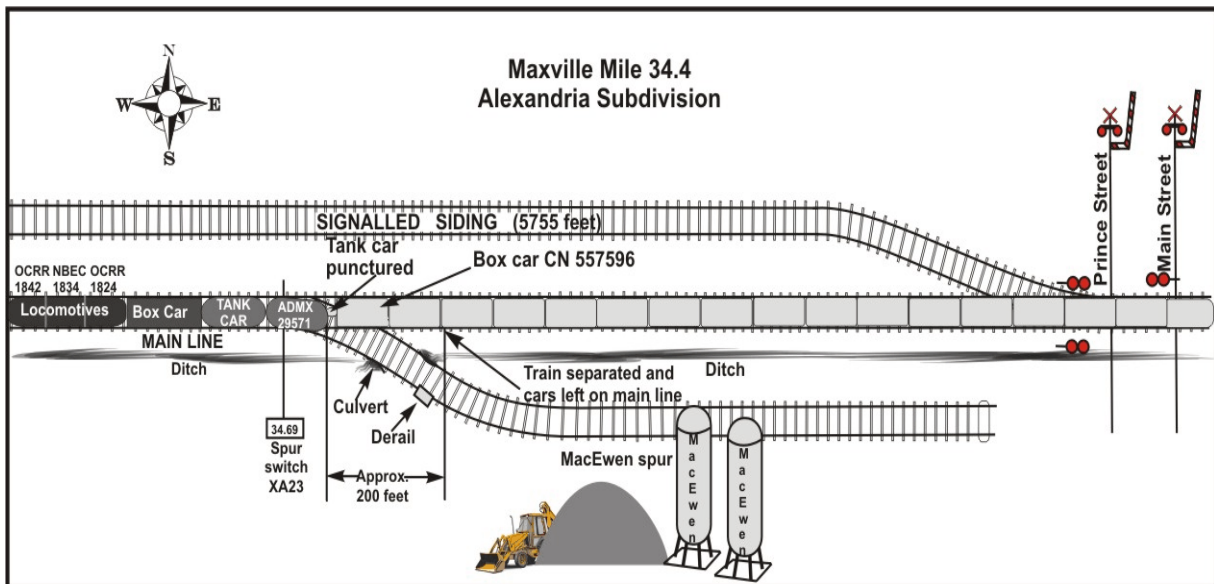
In the area of the accident, the track has an average descending grade of 0.5 per cent between Mile 33.0 and the MacEwen spur switch at Mile 34.69. West of the switch, the track levels off for about 280 feet. A signalled siding runs along the north side of the track from Mile 34.43 to Mile 35.73. There is an eight-foot-deep drainage ditch on the south side of the track (see Figure 2).

Figure 2. Accident site diagram
